**MARYLAND HISTORICAL TRUST  
DETERMINATION OF ELIGIBILITY FORM**

Property Name: Austin Whittington House Inventory Number: S-295  
Address: 5314 Whittington Road North side of Whittington Road, between  
Landon Store and Green Roads Historic district: ☐ yes ☒ no  
City: Marion Zip Code: 21838 County: Somerset  
USGS Quadrangle(s): Kingston  
Property Owner: Swift Farms, Inc. Tax Account ID Number: 049132  
Tax Map Parcel Number(s): 137 Tax Map Number: 58  
Project: Proposed Tower Site: Marion, Somerset County, Maryland Agency: Maryland Dept. of Budget and Management  
Agency Prepared By: A.D. Marble & Company  
Preparer's Name: Stephanie Foell and Stacey Streett Date Prepared: 3/23/2005  
Documentation is presented in: Proposed Tower Site: Marion, Somerset County, Maryland  
Preparer's Eligibility Recommendation: ☐ Eligibility recommended ☒ Eligibility not recommended  
Criteria: ☐ A ☐ B ☐ C ☐ D Considerations: ☐ A ☐ B ☐ C ☐ D ☐ E ☐ F ☐ G  
*Complete if the property is a contributing or non-contributing resource to a NR district/property:*

Survey No. S-295

historic Austin Whittington House

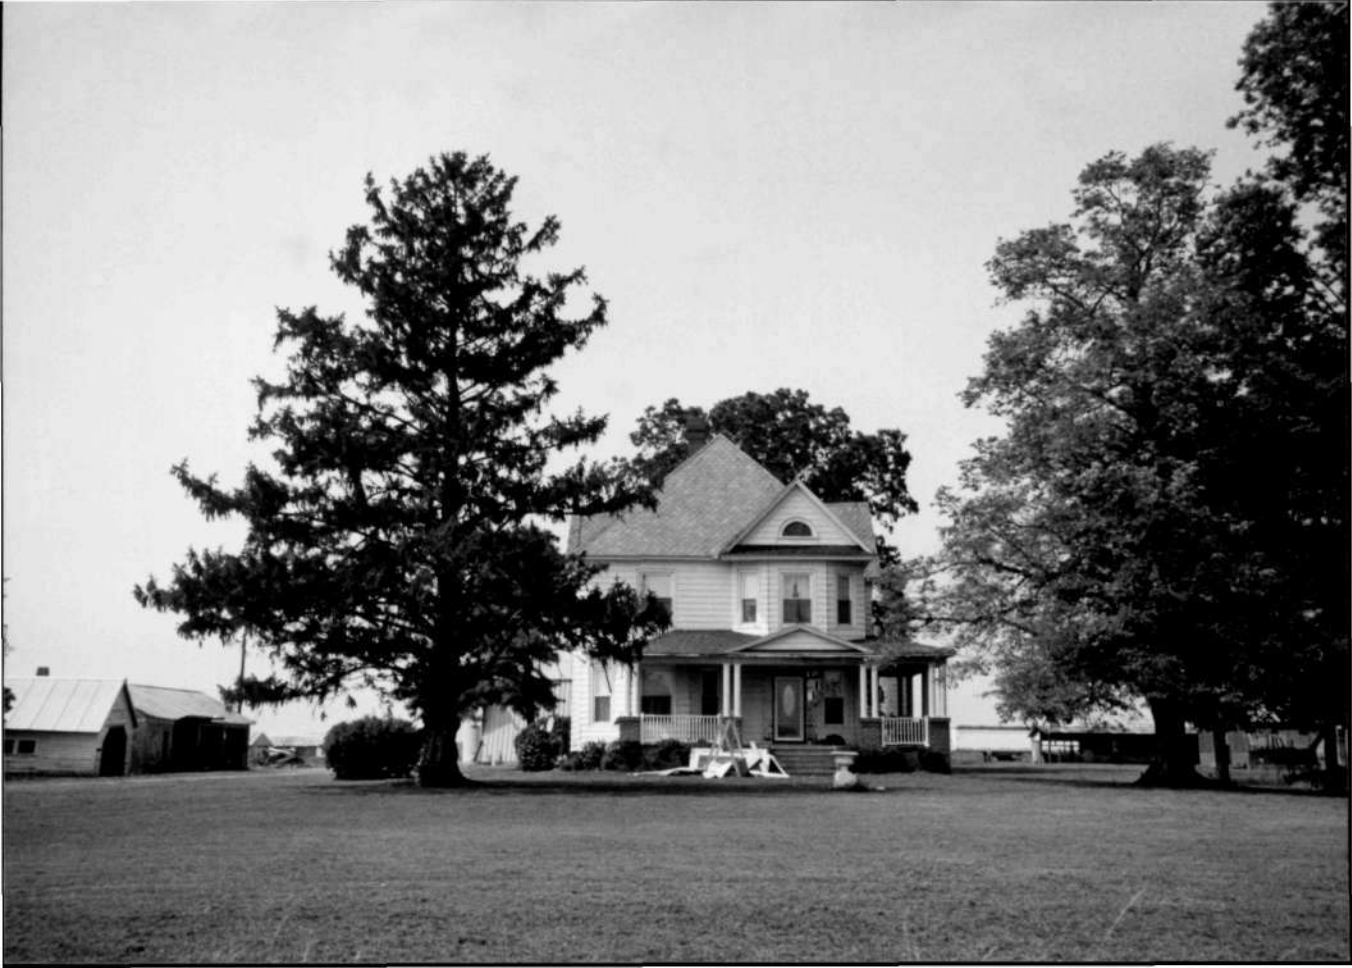
MIHP # S-295

Facade (south elevation), taken from north side of  
Powell Rd. (between Landon Stone and Green Rds.)

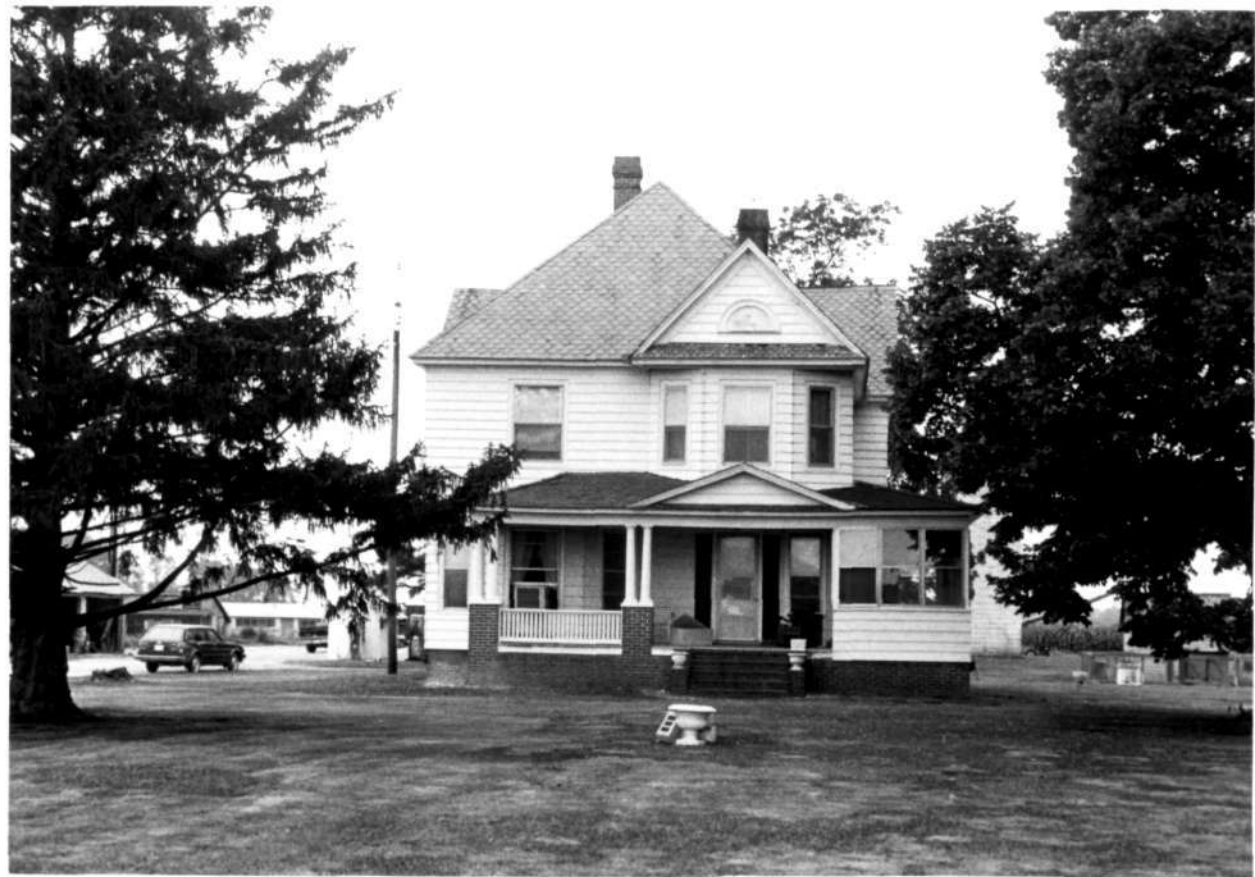
The south (principal) facade is an uneven elevation with the first floor covered by a wraparound porch. Pairs of Tuscan columns on brick plinths support the hip roof. Centered in the middle is a gable-front that marks the entrance bay. The glazed front door is flanked by louvered aluminum shutters while the adjacent bays are filled with single-pane sash windows. The second floor, on the other hand, has a three-sided bay window in the right bay above the entrance and is covered by a gable-front roof pierced with a lunette window. The left bay on the second floor has a single-pane sash window.

Austin Whittington House                      S-295  
Tulls Corner vicinity, Somerset county  
South Elevation  
8/85, Paul Touart, Photographer  
Neg./Md. Historical Trust

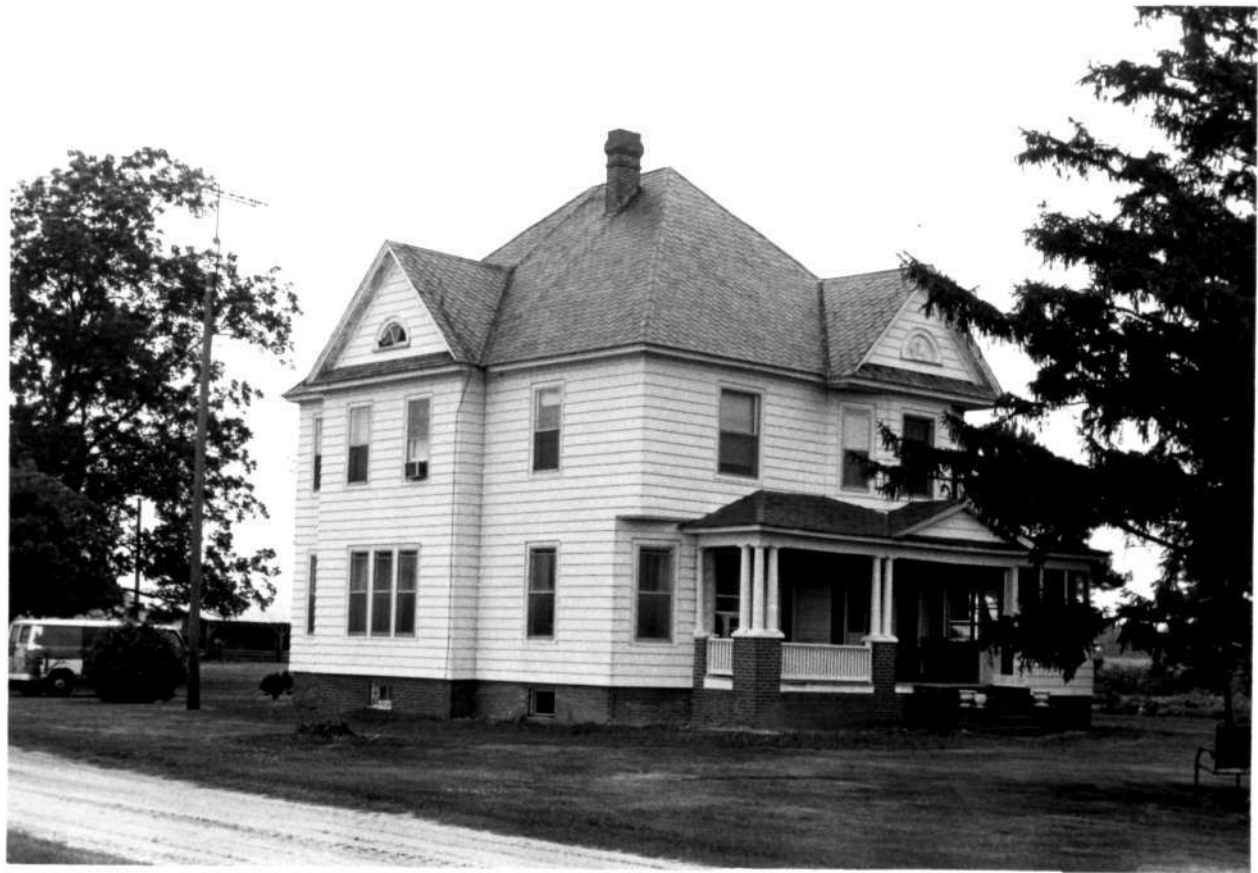
The west side elevation has an off-center two-story bay covered by the same gable-front roof with a lunette window. The flanking bays are filled with single-pane sash windows, and the cellar is lighted by two-pane lights.

Austin Whittington House      S-295  
Tulls Corner, Somerset County  
Southwest Elevation  
8/85, Paul Touart, Photographer  
Neg./Md. Historical Trust
